Our Reference: RCC-171027-Heffron park-clr-letter

ASBESTOS CLEARANCE INSPECTION & AIR MONITORING FOR REMEDiated ASBESTOS-CEMENT AREAS HEFFRON PARK, MAROUBRA

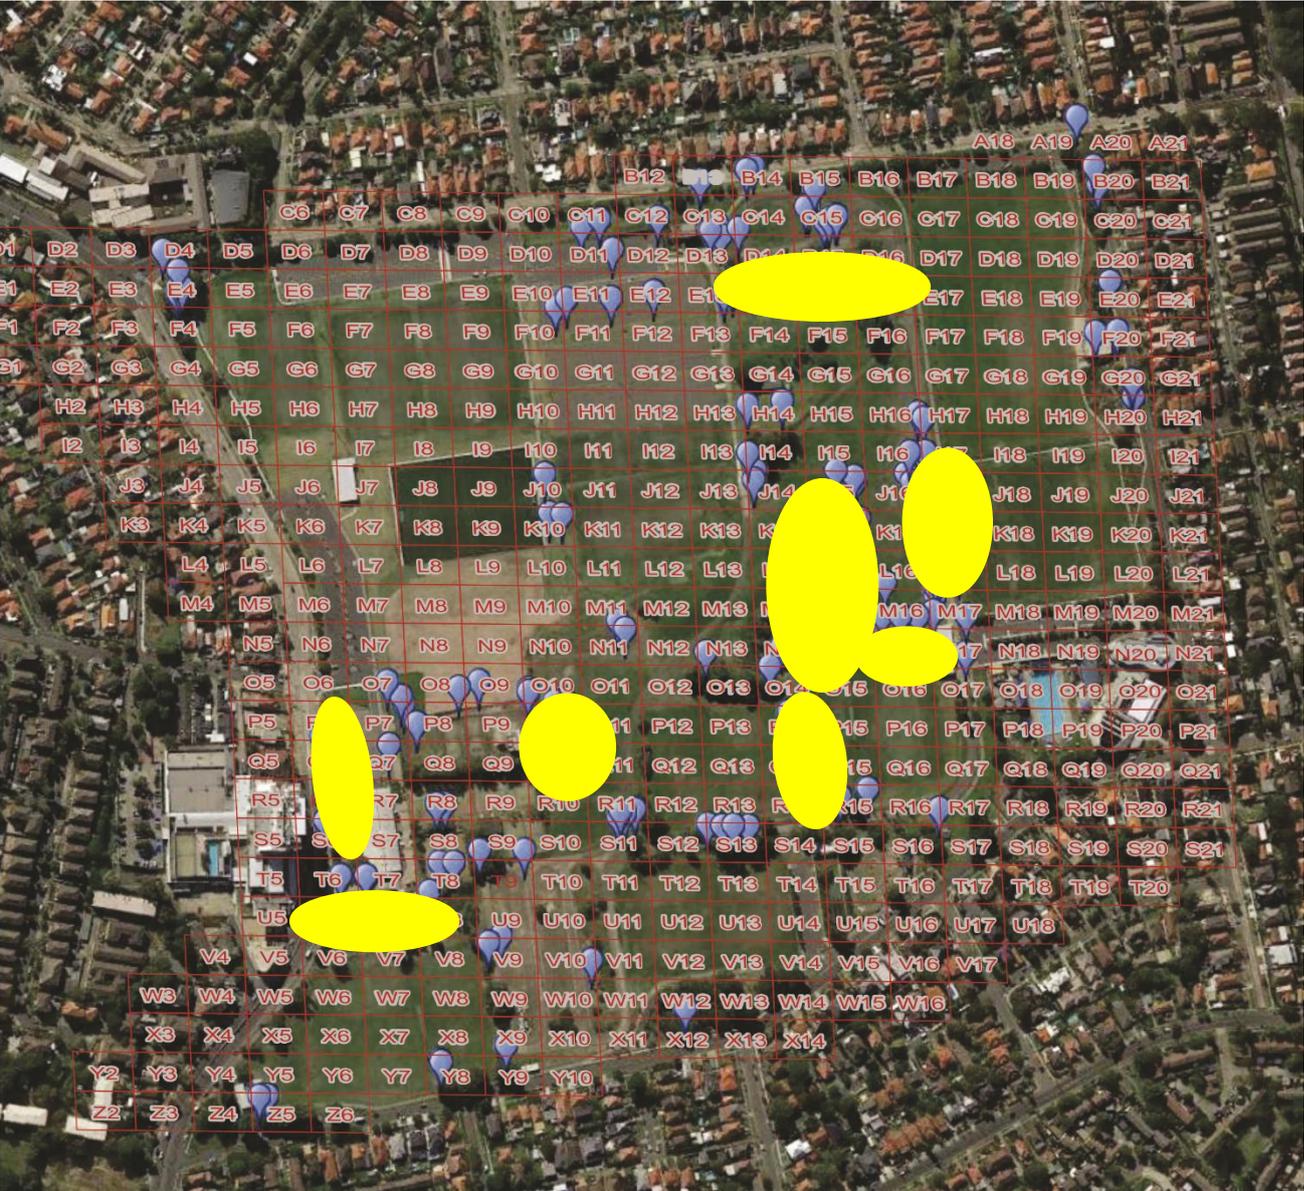
HEFFRON PARK MAROUBRA
AREAS OF ASBESTOS CONTAMINATION REQUIRING REMEDIATION

1. Grid Areas N15-N17. Area West of Amenity/Clubhouse Building (adjacent to Swimming complex Carpark). 7
2. Grid Areas I16/17-K16/17 & L17-M17. Area North of Amenity/Clubhouse Building (adjacent to Swimming complex Carpark).
3. Grid Areas S11 Corner north of Cycle track opposite AFL playing field.
4. Grid Areas O10-R10. Area east of tennis/squash courts and fenced off excavation area, with hill to the east.
5. Grid Areas E13-E15. Area along log post & wire fence, bordered by cycle track to north & netball courts to south.
6. Grid Areas O14-R14. Old retaining wall of sleepers with trees dividing two playfields north of Cycle track.
