**Randwick City  
Council**  
a sense of community

## **WORKS COMMITTEE MEETING**

**TUESDAY 12 APRIL 2016**

**Subject:** 18 Judge Street, Randwick - Private retaining wall

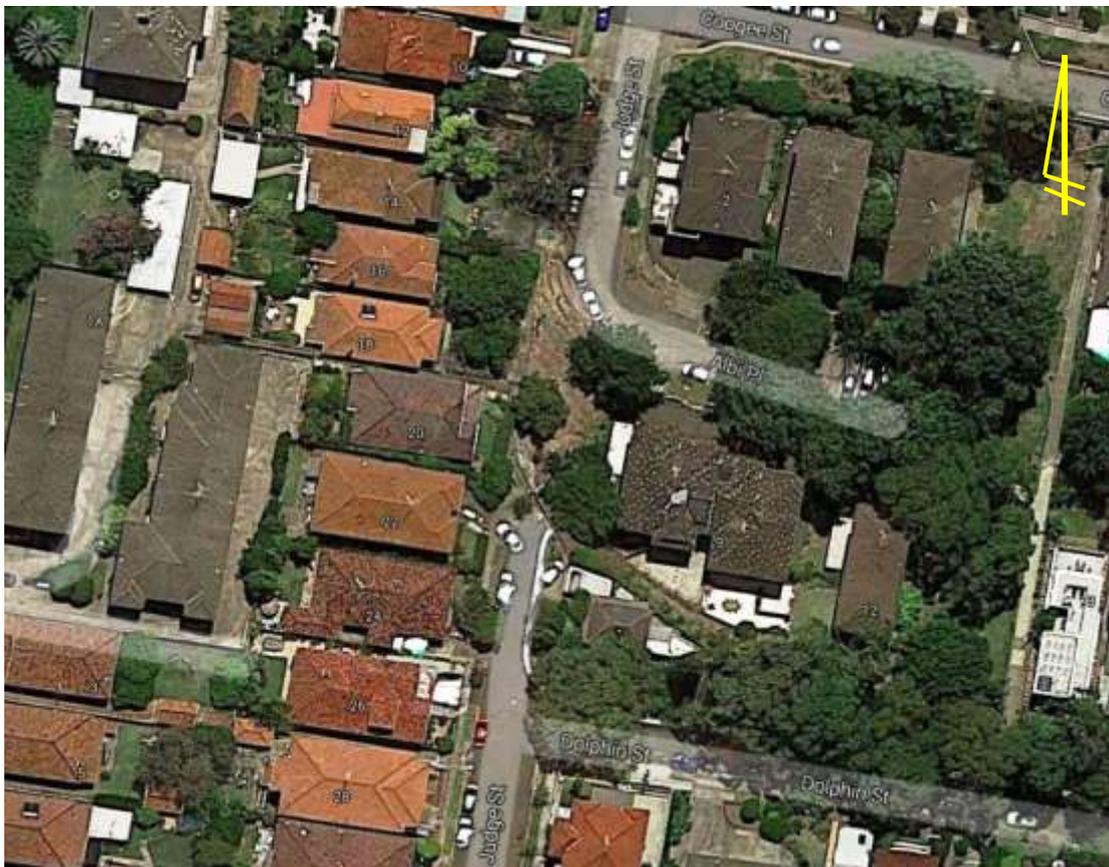
The land around 18 Judge Street is characterised by a sharp drop in topography. Judge Street is separated into 2 sections due to the topography of the land that is cut by a sandstone cliff. Access between the 2 sections of Judge Street is only available for pedestrians via public stairs and a walkway. An aerial view of this arrangement is shown below.

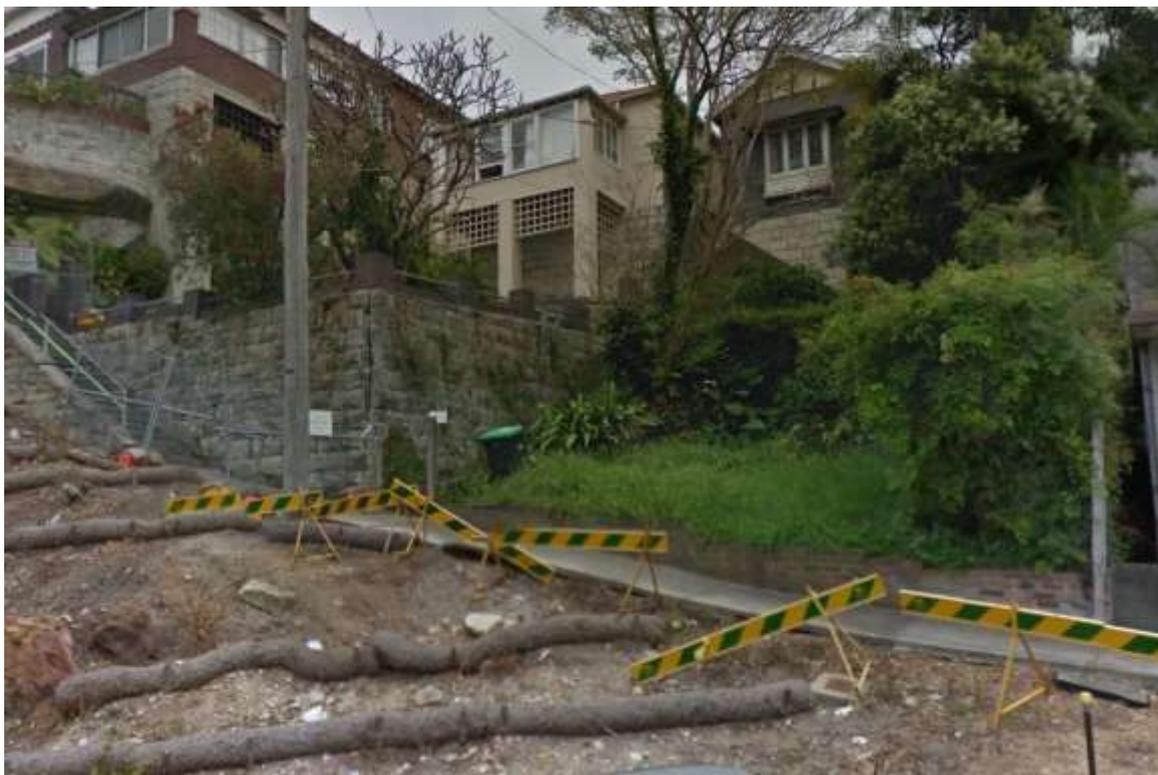
**Photograph of Retaining Wall, Stairs and adjacent property**

The retaining wall on the eastern boundary of 18 Judge Street is cracked and bulging and is in the process of failing. Council has isolated the adjacent footpath and stairs until the wall is repaired or made safe. The owner of 18 Judge Street has made numerous approaches to Council for contributions towards some or all of the costs associated with rebuilding the wall.

In 2013, Council staff was alerted to the deteriorating condition of the sandstone retaining wall along the frontage of 18 Judge Street. The retaining wall was inspected and in the interests of public safety, it was deemed necessary to isolate the stairs and walkway below the wall.

A structural assessment of the wall was undertaken in October 2015. The structural report concluded that the mechanism of failure is a combination of foundation settlement and excessive earth pressure. The wall structure was measured and found to be inadequate for the height of the wall. The settlement issues were reported as being likely due to inadequate wall footings.

- a) Council issue an Order to the owner of 18 Judge Street to obtain a structural design and reconstruct the heritage retaining walls as required to support their land along the Judge Street frontage.
- b) Council commit to funding the reconstruction of any stair treads that may be required to be removed to facilitate the reconstruction of the wall.

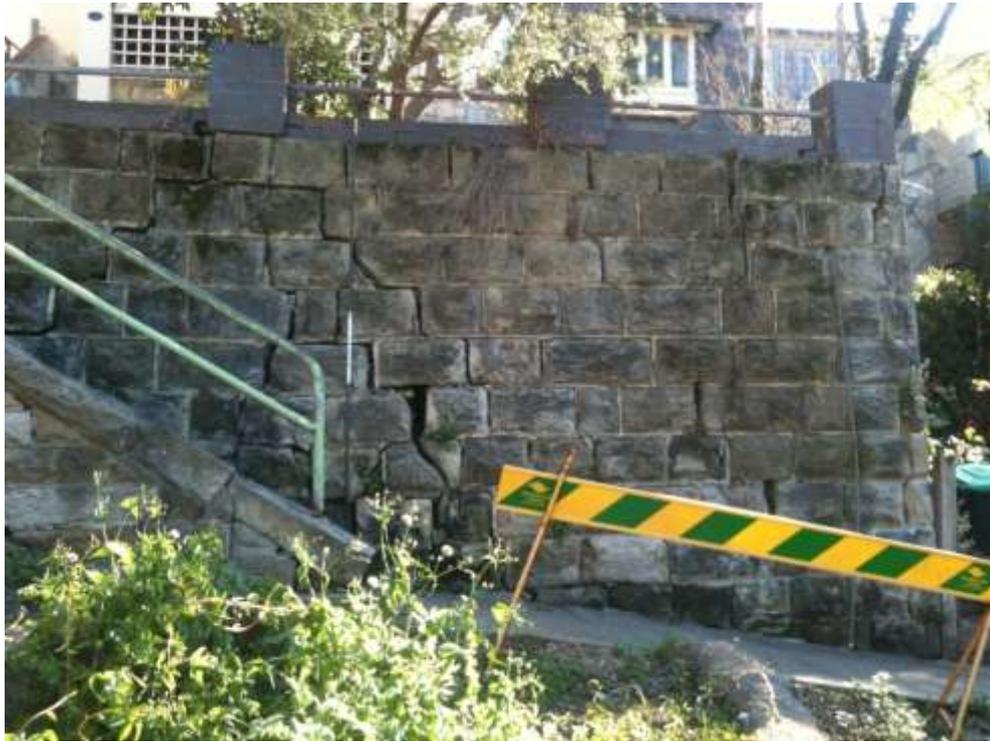
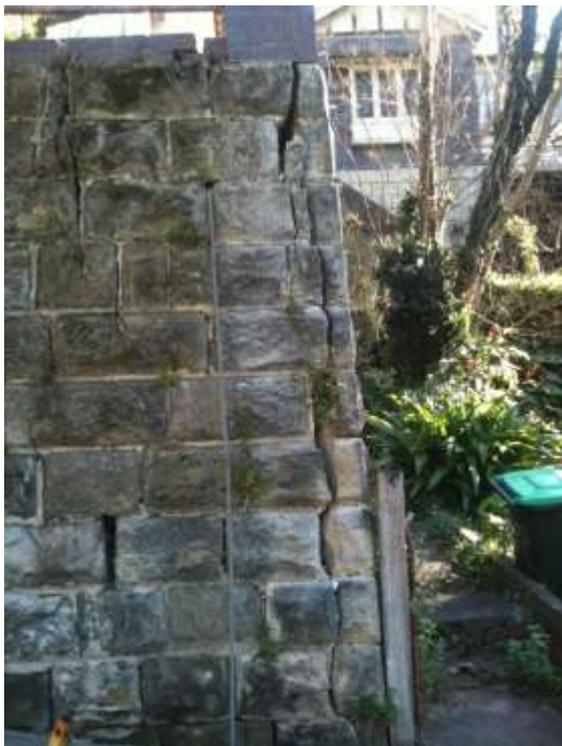
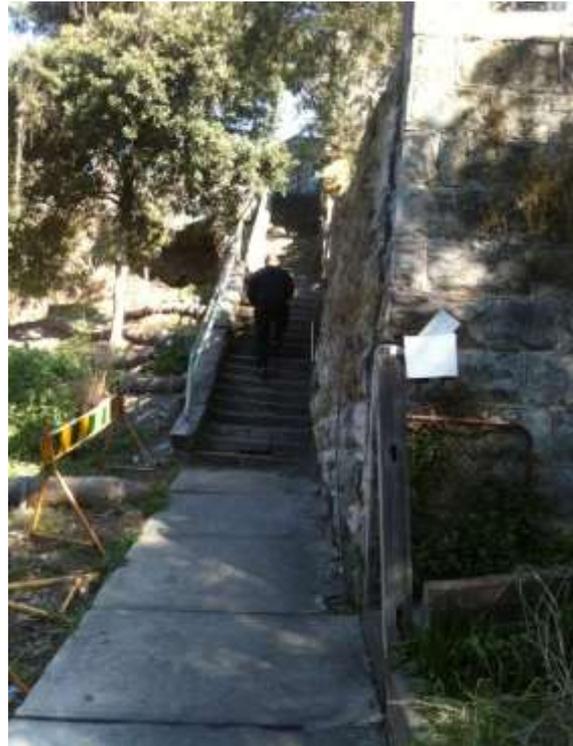
<b>Owner's Claim for Council Contribution</b>	<b>Council review of Owner's Claim</b>
	<p>The property at 18 Judge Street was developed in 1928. An aerial photo from 1930 shows the dwelling in existence and also a crisp line in the location of the existing retaining wall which casts a shadow in the shape of the wall.</p> <p>An inspection by an experienced stonemason found the stones used in the stair wall to be different in shape to the stones used in both the boundary wall and also walls located within 18 Judge Street. The stonemason also identified differences in the bedding mortar and the pointing between the boundary wall and the wall on the outside of the stairs.</p> <p>It can now be reasonably concluded that the boundary retaining wall at 18 Judge Street was in existence prior to the construction of the Council steps.</p>
<p>A Council stormwater pipe failure played a role in the degradation of the wall's condition.</p>	<p>Council's stormwater pipe overflowed during a significant storm in the rear yard of 1A Ada Street at a location approximately 60m west of the wall.</p> <p>The Coogee Bay Flood Model confirms that the stormwater pipe's capacity is exceeded in the 1 in 5 year storm, causing water to flow overland along this flow path. This confirms that the wall is located on a natural and active flow path.</p>
